**SUBJECT: FINAL RCRA CORRECTIVE ACTION SITE VISIT REPORT
USACE CONTRACT NO. W912DQ-08-D-0019
TASK ORDER NO. 005A**

FINAL RCRA SITE VISIT REPORT

**Maryland Environmental Services Hawkins Point Controlled
Hazardous Substance Landfill
EPA ID No. MDD 000 731 356
5501 Quarantine Road
Baltimore, MD 21226**

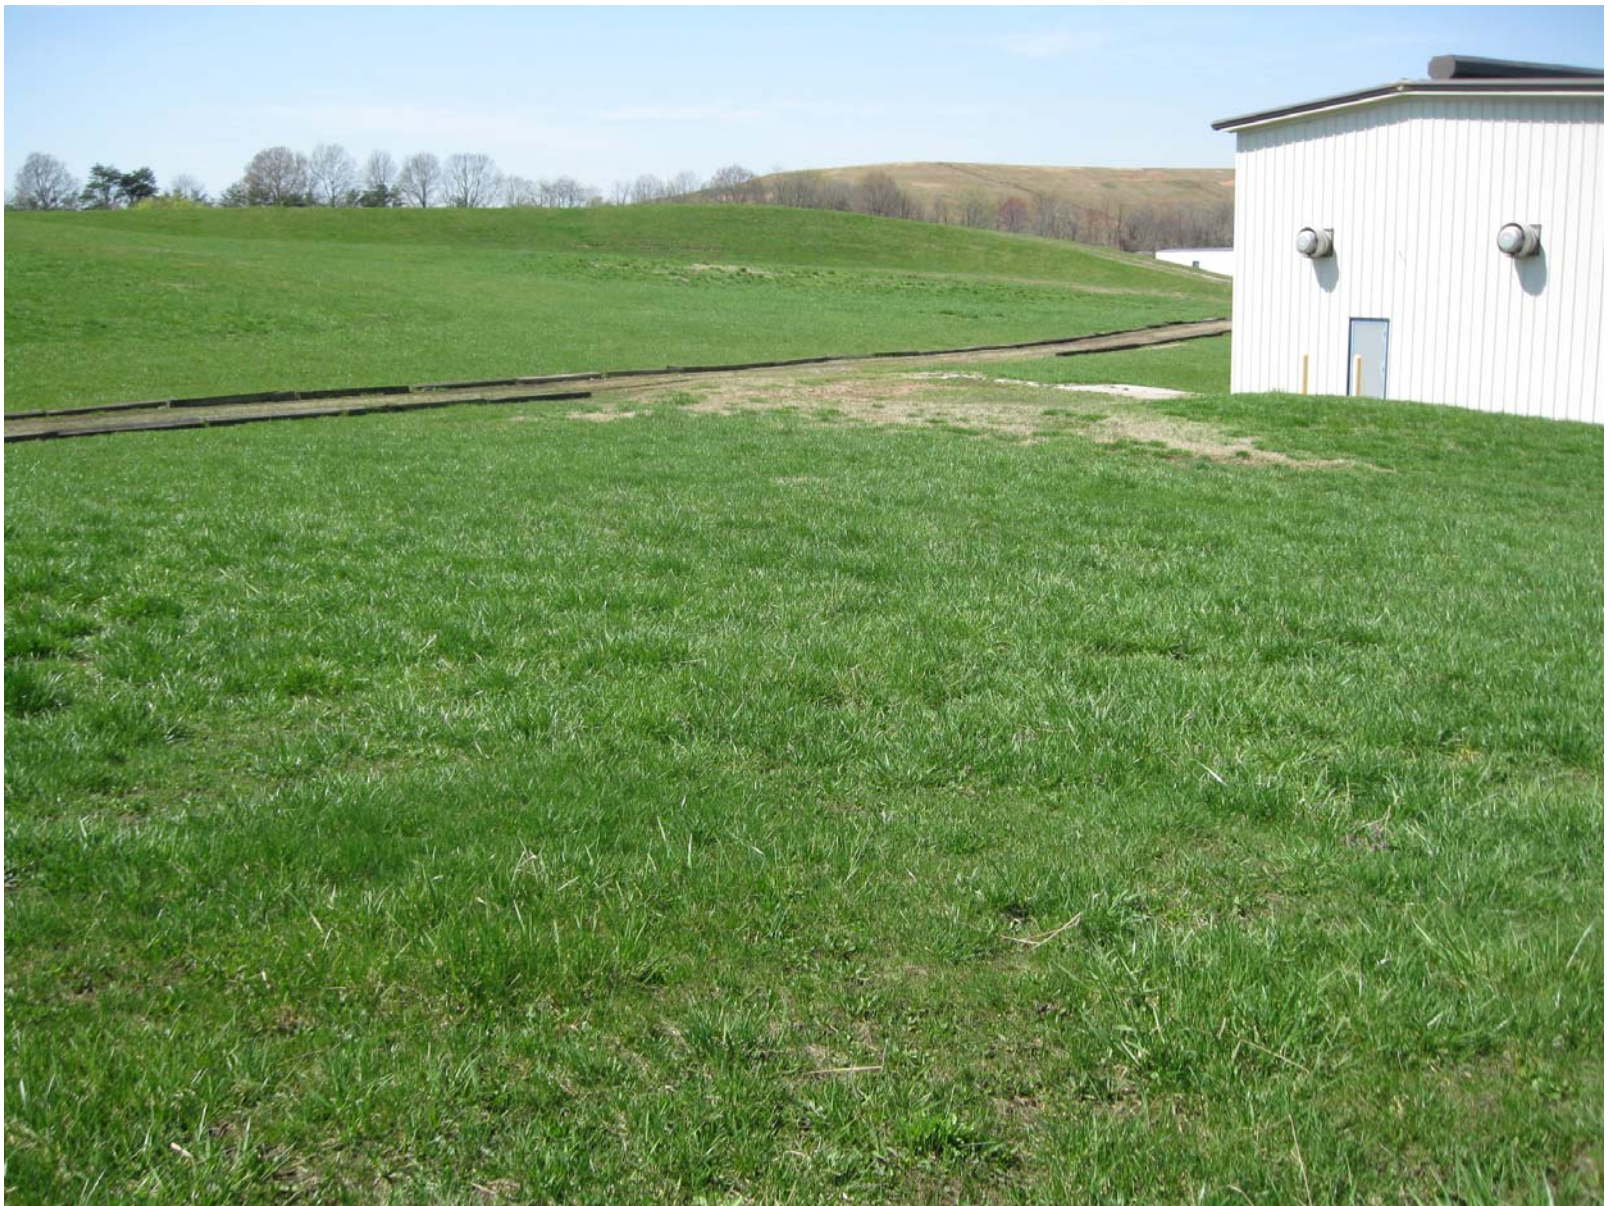
Photograph 12: SWMU No. 10 – Location of Former Lab Trailer

The on-site trailer was used previously as a laboratory where samples were analyzed before COPR was accepted for disposal in the landfill cells when they were in operation. Once the facility stopped accepting COPR, the laboratory trailer was removed from the site. SWMU No. 10 is shown in Photograph 12 in Appendix A at the time of the 2010 RCRA Site Visit.
